## TRAIL ASSESSMENT FORM

Doc. #		Trail Name	Old Furnace Brook Path	Trail Type:	Wide – multi use	Condition	Good
<b>Route:</b>		Craggs Foot Path 4145 - Sawcut Notch Path 4180					
<b>Recent Weather:</b>		No rain within last 48 hours. Sunny in the 70's					
<b>TRAIL LANDMARKS</b>		<ul style="list-style-type: none"> <li>• Trailhead leaves from the north side of Craggs Foot Path at intersection marker 4145. Treadway is road width.</li> <li>• Culvert crosses under the treadway at .21 miles. R to L. Rockwork/earthen construction. 12" clay pipe with lots of debris. Cleaning of ditch, wells and pipe needed (1)</li> <li>• Runoff in treadway from .24 through .26 Very muddy and side trails around the area are starting to form. See photo 1. (2)</li> <li>• Culvert crosses under the treadway at .27 miles. R to L. Rockwork/earthen construction totally impacted on right with no pipe visible. 12" clay pipe noted on left 3/4 full. Cleaning of ditch, wells and pipe needed. Runoff noted in previous bullet would be eliminated if this culvert was operating properly. Note: investigate for this culvert as it was not found during survey as of 5/10/16. (3)</li> <li>• Culvert crosses under the treadway at .3

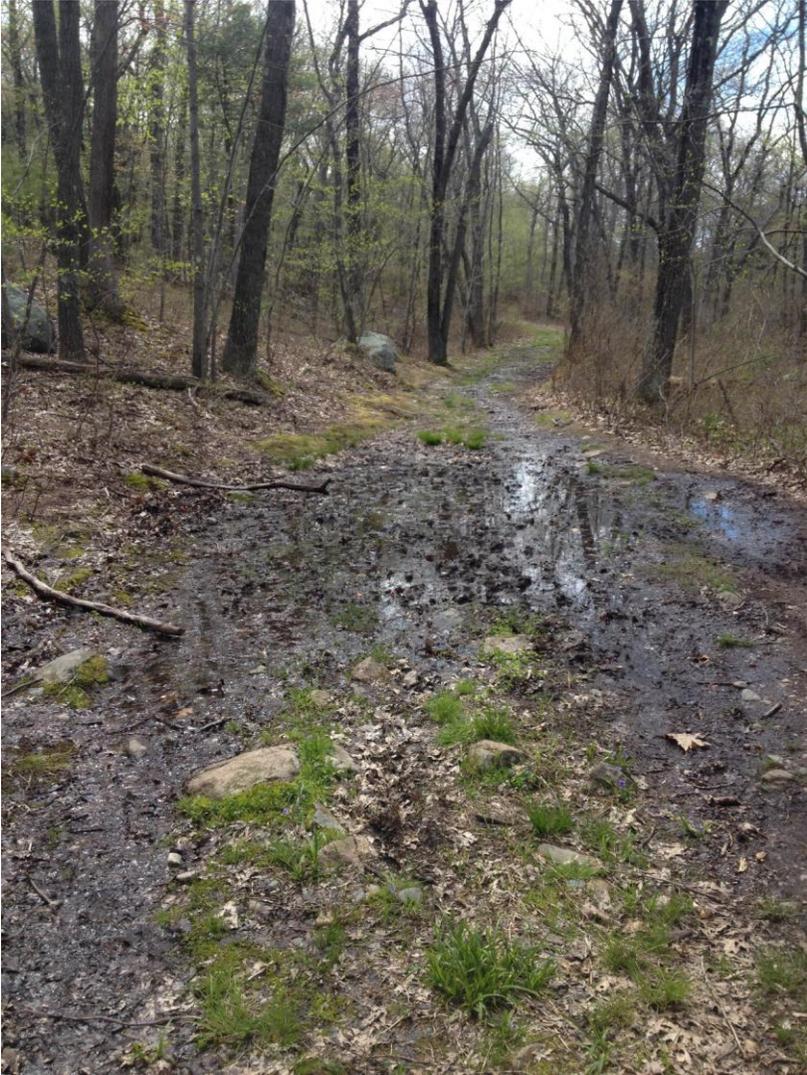
Photo 1:

<b>MINOR&amp;MAJOR PROBLEM AREAS</b>		<ol style="list-style-type: none"> <li>(1) Culvert crosses under the treadway at .21 miles. 12" clay pipe. Needs cleaning of ditches on both sides and pipe.</li> <li>(2) Runoff in treadway at mile .24 causing a muddy area and creation of side trails. Section needs a culvert. See photo 1.</li> <li>(3) Investigate for previously present culvert that is not currently visible at .27 miles. Potential solution for problem 2.</li> <li>(4) Culvert crosses under the treadway at .30 miles. Pipe full of debris and needs cleaning, as do the ditches on both sides.</li> <li>(5) Two culverts at the intersection between Old Furnace Brook Path and Sawcut Notch Path connect with a ditch. Both culverts and ditch need cleaning.</li> </ol>					
<b>DISTANCES TO MAJOR INTERSECTIONS</b>		<ul style="list-style-type: none"> <li>• Craggs Foot Path intersection marker 4145 to Sawcut Notch Path intersection marker 4180 - .35 miles</li> </ul>
