TRAIL ASSESSMENT FORM

Doc. #	3002	Trail Name	Romari Trail	Trail Type:	Narrow M	Condition	Good
Route:		Starts at east end of Wood Path, heading southwest along the park boundary, ends at another un trail. Approx. ¼ mi. long					
Recent Weather:		Has snowed and mostly melted since. Trail is muddy in some spots, dry others, snow/ice covered in spots also.					
TRAIL LANDMARKS		<p>*Access from Wood Road gate at Wood path. No legal parking but a large lot across Wood Road.</p> <p>*Trail starts at about 70 yards in on Wood Path(heading west)on the left.</p> <p>*The map shows this trail as perfectly straight, running along the park boundary for ¼ mi. It does meander some, with slight rolling hills.</p> <p>*Mostly hard pack terrain, but some technical with loose rocks on the hilly sections.</p> <p>*Biggest landmarks are the industrial businesses on the SE side of the trail that can be seen and heard from most of the trail.</p> <p>* 8ft. bb with stagnant water 141 yds from start(1)</p> <p>*cv/dt at same point, leading under ind. park lot.</p> <p>*rw/cv behind ind. pk.pkg lot 257 yds. The rw/cv on the SE side of the trail is approx 10 yards back from the trail, draining perpendicular to tra

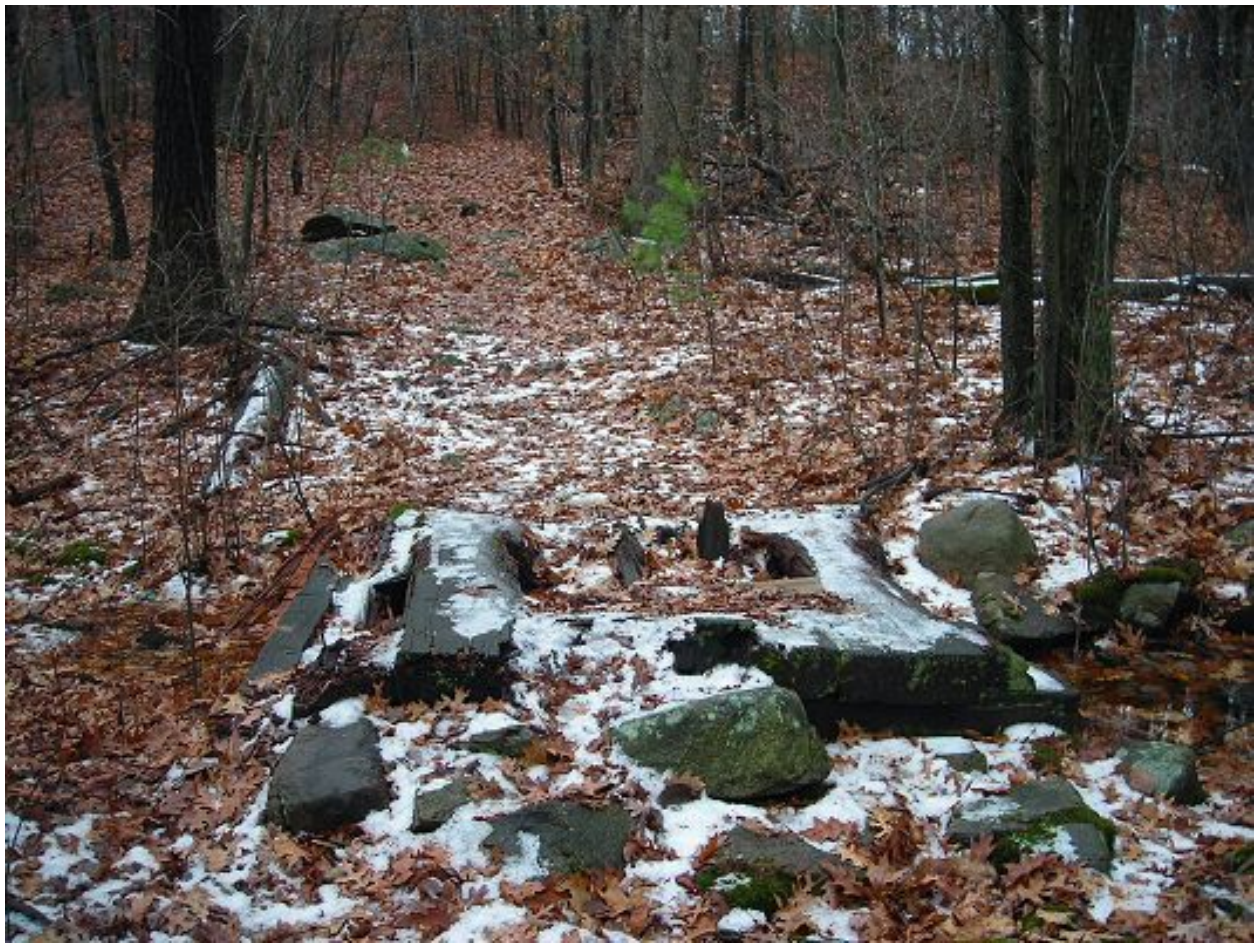
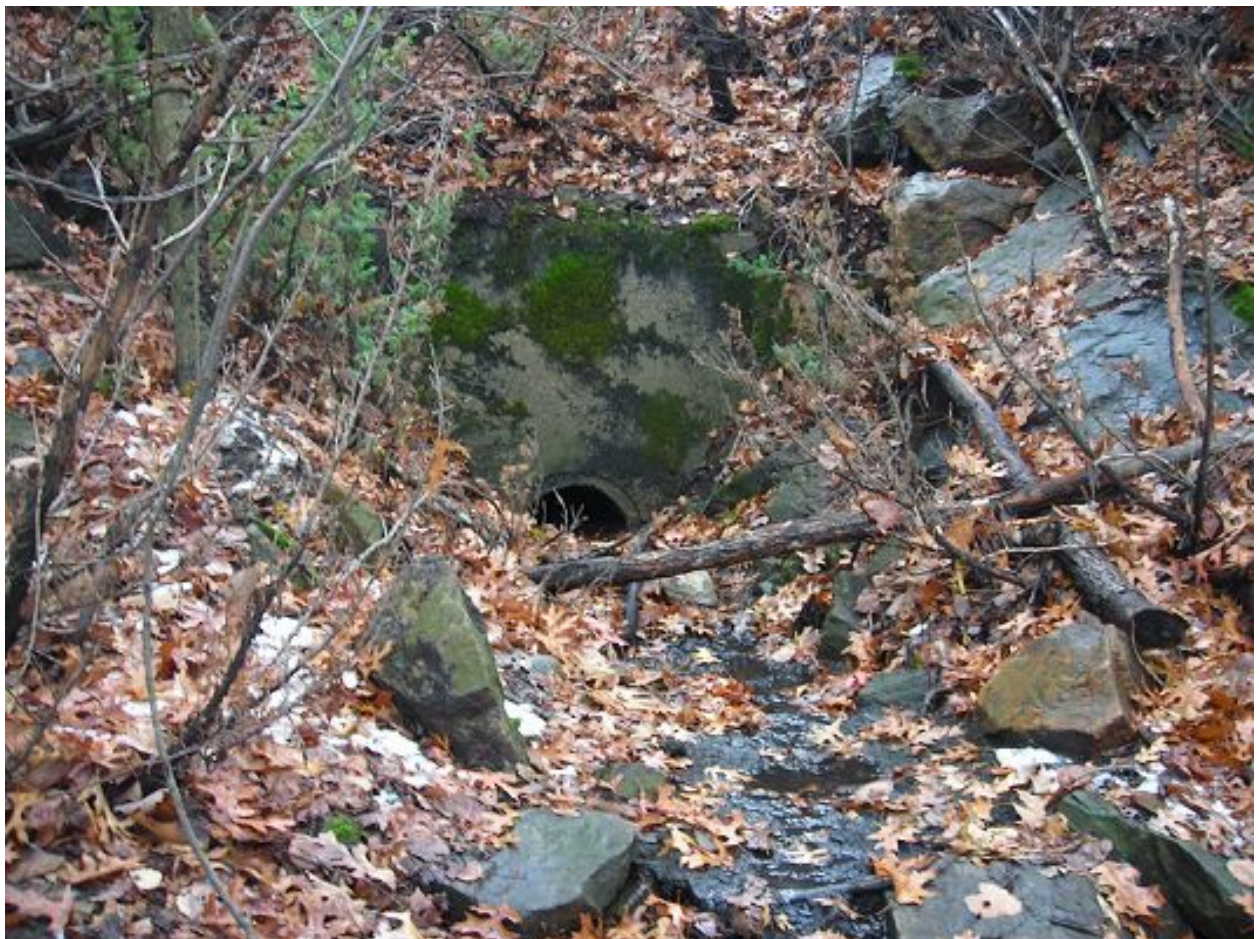
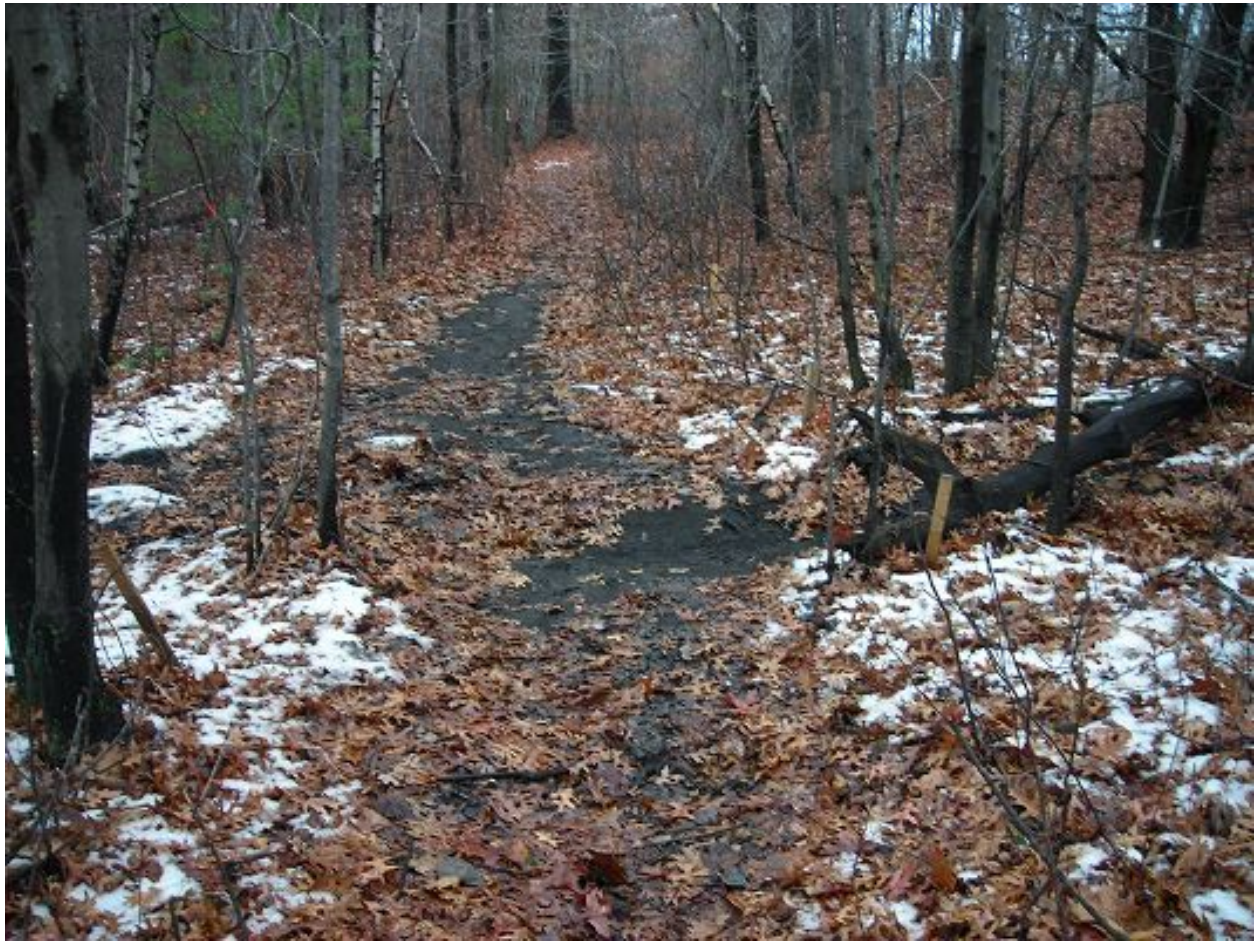
MINOR PROBLEM AREAS		A cutback crew could easily maintain this trail in less than an hour.					
MAJOR PROBLEM AREAS		<p>1) bb/cv/dt drainage issues. BB is in bad shape, needs replacing. An armored stream crossing with 'stepping stones' would probably suffice. Whether the cv functions well is unknown, may handle spring runoff, but is not helping drain now. Water that crosses the trail is not moving at all. Backup of leaves at this point are part of the problem, however, this part of the trail runs next to a bog.</p> <p>The cv is out of park boundary</p> <p>(2) This rw/cv is a storm runoff that runs down the rock embankment and apparently washing silt down across trail. This has resulted in a muddy stretch approx. 20 yards long. This could be alleviated by building an armored ntd/rd.</p>					
DISTANCES TO MAJOR INTERSECTIONS							
Report prepared by:			Steve Cobble		Assessment date:		12/12/07
