## TRAIL ASSESSMENT FORM

Doc. # Trail Na	ne Brookwood Trail Trail Type:	Narrow Condition Good
Route:	Hillside Ave. – 1062 – Wildcat Notch Path	
<b>Recent Weather:</b>	Drizzly, 50's, 1" of rain last night	
TRAIL	• Trailhead is located on the north side of Hillside Street approximately	
LANDMARKS	3/8 of a mile west of the Hillside Street, Blue Hills River Road	
	intersection.	
	<ul> <li>Trailhead is fairly hidden from the street however opens to a footpath once into the woods. Trailhead should be marked. Located across the street 300 feet from the Brookwood Road.</li> <li>Accord Path Marker 1062 crosses at 307 feet. There is a ditch that</li> </ul>	
	collects water from Brookwood Trail and moves it across Accord Path.

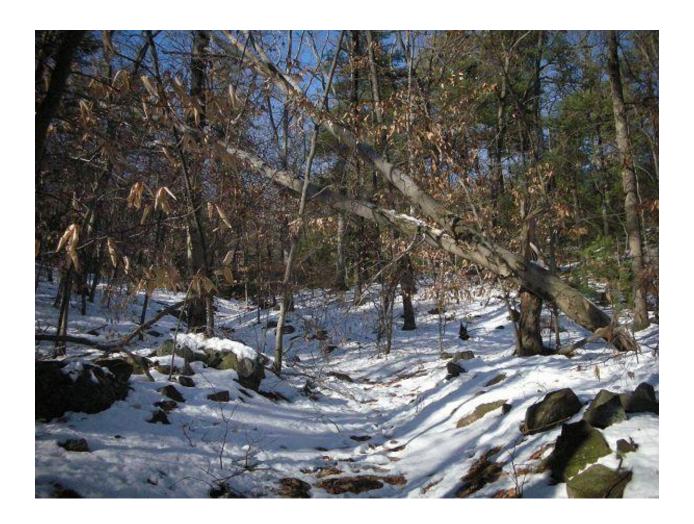
• Series of stone waterbreaks heading up the hill starting at 350 feet.	
	Stone waterbar, R to L, at .1 miles. Clean and improve.	
	• Stone waterbar, L to R at .18 miles. Clean.

• Series of stone waterbreaks at .19 miles.	
	• Rock walls on L and R at .20 miles.	
	• Wooden waterbar, L to R, at .22 miles. Clean.	
	Brookwood Trail ends at intersection with the Wildcat Notch Path just	
	south of the Marker 1083 at .41 miles. Swale collects water from	
	Brookwood Trail and moves it across Wildcat Notch Path.	
MINOR&MAJOR	None	
PROBLEM		
AREAS		
DISTANCES TO	Hillside Street Trailhead to Accord Path Marker 1062 – 307 feet.	
MAJOR	• Hillside Street Trailhead to Wildcat Notch Path41 miles.	
INTERSECTIONS		
Report prepared by:	Bob Flagg Assessn	nent date: 2/4/16
