TRAIL ASSESSMENT FORM

Doc. #	1018	Trail Name	Accord Path West	Trail Type:	Wide - M	Condition	Poor
Route:		Hillside Street FBH 1161- 1151 – FBH1137 - FBH1136 - FBH1125 – FBH1105 – FBH 1097 – FBH1096- 1086 – 1081 – 1062 – FBH1040 – FBH1013 – FBH1004 - Skyline South FBH1003 – FBH1005 – FBH1110 - Blue Hills Ski Area					
Recent Weather:		1/25/08 - Cold and Sunny in the 20's – Snow cover on trail was 0-2 inches. 5/15/08 – Cloudy in the 60s. Light rain in last 24 hours					
TRAIL LANDMARKS		<ul style="list-style-type: none"> • Trailhead leaves from the north side of Hillside Street at path width, directly across from the northeast corner of the Houghton Pond parking area. Trailhead is marked with three large rocks. • For the purpose of this assessment, both the DCR (8/07) and the old FBH maps were used in the survey. Some portions of this trail do not appear on the DCR map. There is also one section of this trail shown on the FBH map that does not currently exist any more (overgrown and not navigable). It is however shown correctly on the DCR map. For these reasons, I will note both the DCR and FBH intersection markers for clarification and comment as required. • Treadway begins ascendi

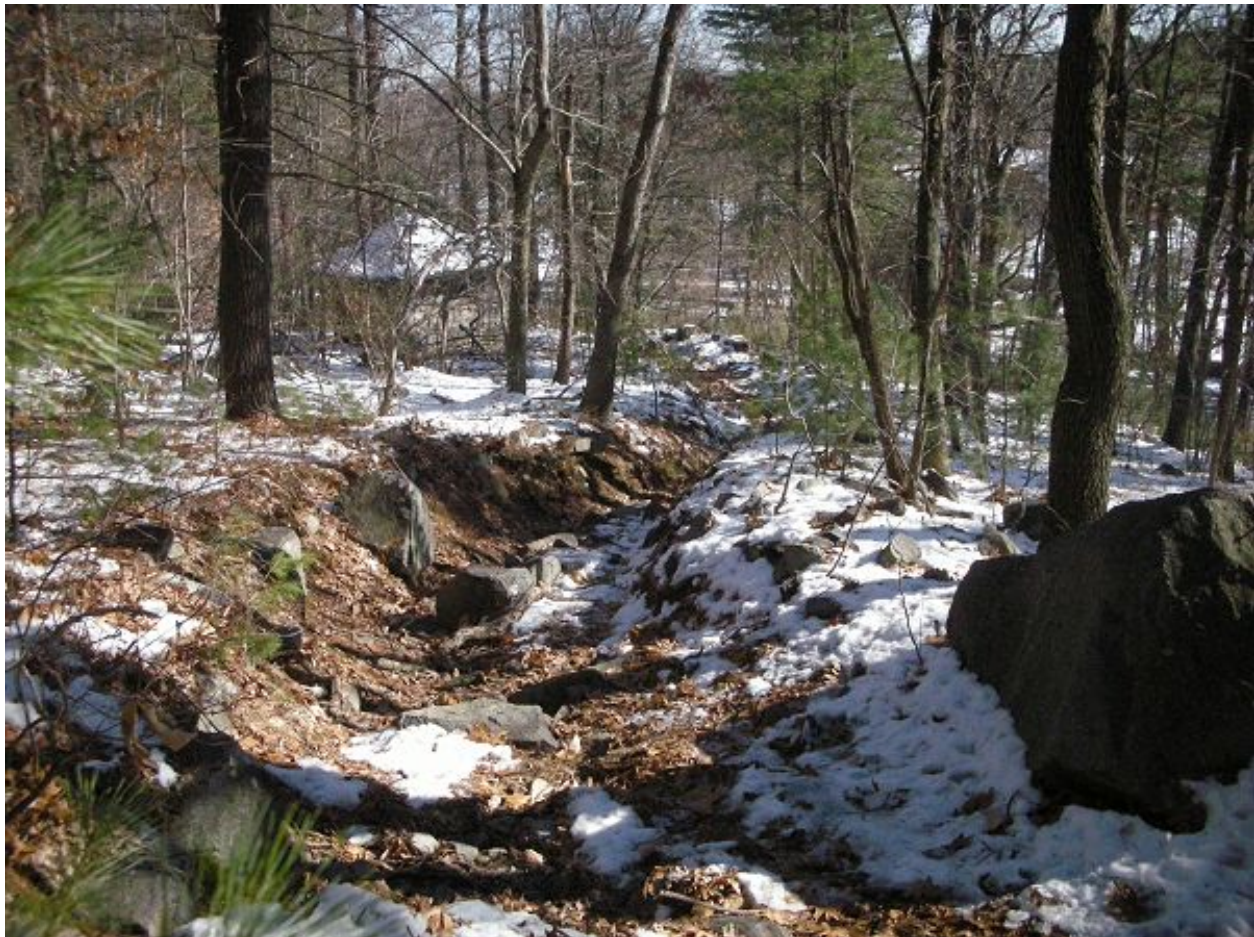
MINOR PROBLEM AREAS	<ol style="list-style-type: none"> 1. Accord Path leaves the current (west) wide path on the right at .37 miles. This is a narrow lightly traveled path heading north. (No FBH 1125 noted) Need intersection marker here. (1) 2. Lbd with limbs extending into the treadway at .42 miles. Limbs need to be cutback. (2) 3. Widow maker .81 miles from trailhead, 20" dia. Remove before season. (3) 7. Lbds cross trail at 1.49 and 1.50 miles. Needs removal and Bn. (7) See Photos. 3 & 4 8. Broken limbs block trail at 1.51 miles needs removal. (8) See Photo 5.
MAJOR PROBLEM AREAS	<ol style="list-style-type: none"> 4. Moderate to severe erosion continues as this trail ascends through 1.32 miles. It appears to me that this trail is intentionally used to channel runoff from the hill on the right of the trail. There is Rwk on the side of the trail in some areas to keep the runoff on the trail and divert it into Dt and sewers located on Hillside Ave. See Photo. (4) 5. Dt on right side of trail paralleling trail for a short distance at 1.32 miles. Bd in Dt needs to be removed. Extending this Dt back to 1.2

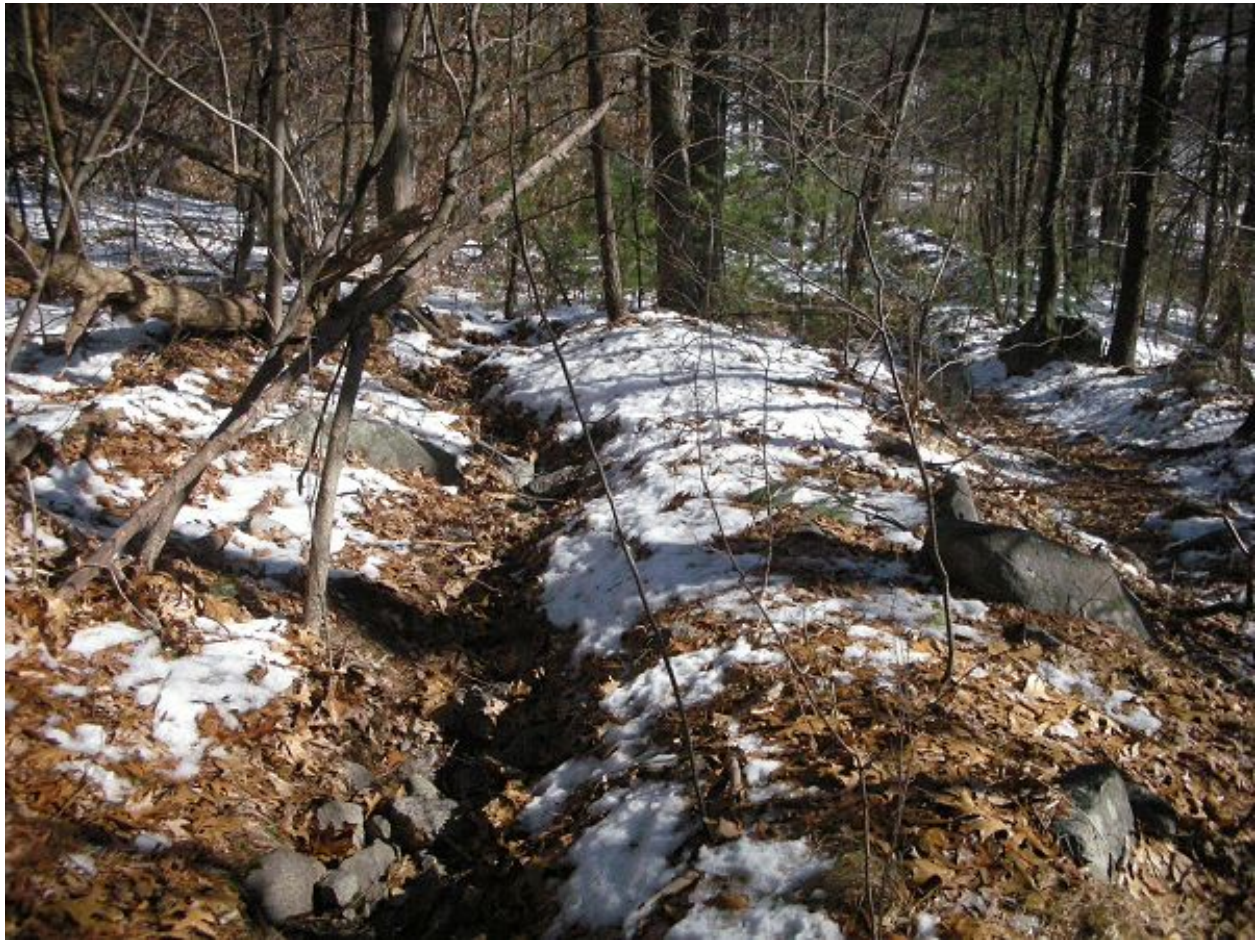
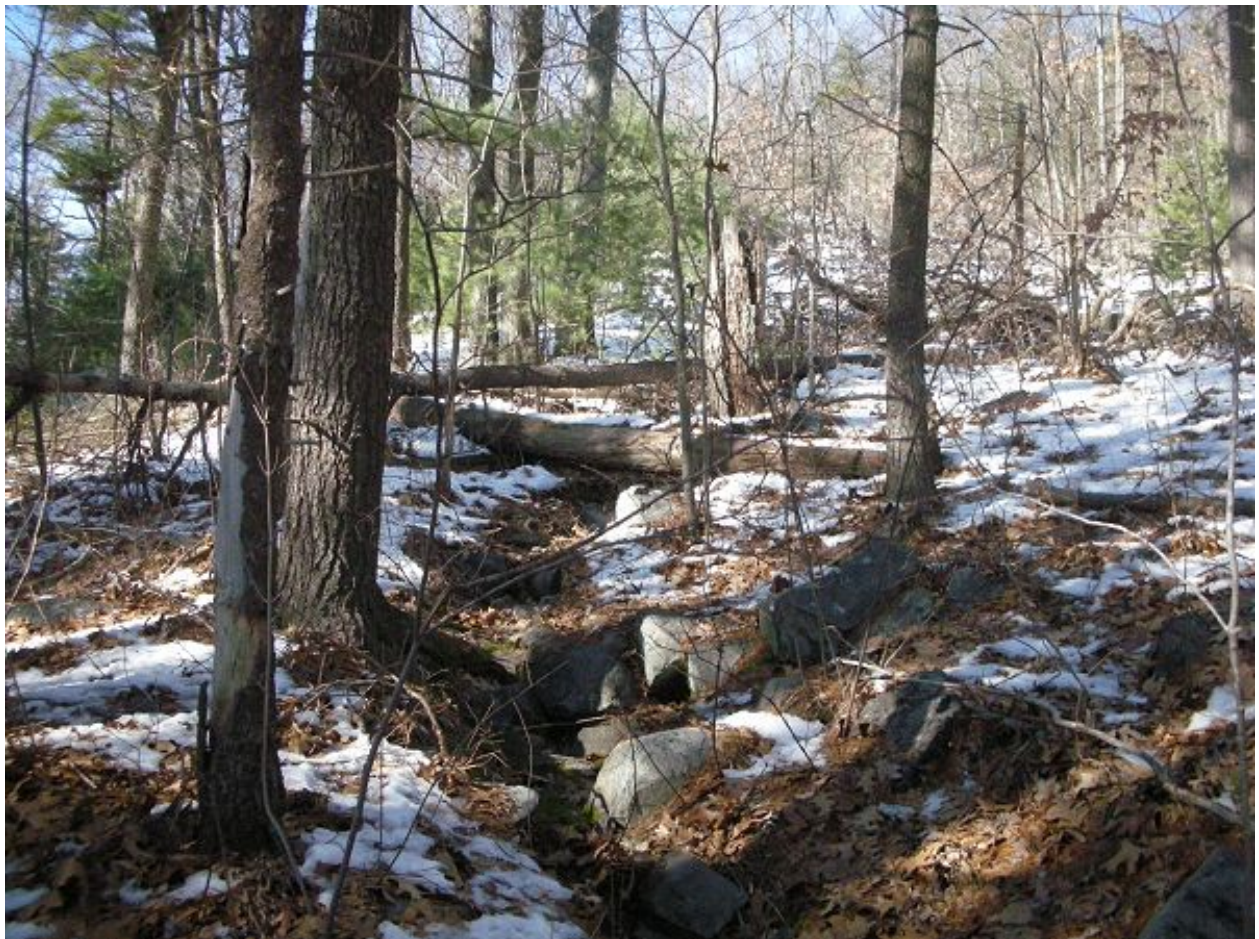
<p>and sewers located on Hillside Ave. See Photo. (4)</p> <ul style="list-style-type: none"> • Dt on right side of trail paralleling trail for a short distance at 1.32 miles. Bd in Dt needs to be removed. Extending this Dt back to 1.2 miles would minimize treadway erosion through this area however this would be a major undertaking. See Photo. (5) • Sbd (6" dia.) at 1.36 miles. Remove. • Dt on left at 1.38 miles with Bd across it. Requires cleaning. • Sbd at 1.42 miles extending into trail. Needs to be cut back. • Sbd at 1.43 miles needs to be removed. • Trail descends into an area of moderate to severe erosion at 1.43 miles. Again it appears to me that this trail is intentionally used to channel runoff from the hill on the right of the trail. Rkw on left. (6) • Bn at 1.44 miles. • Lbds cross trail at 1.49 and 1.50 miles. Needs removal and Bn. (7) See Photos. 3 & 4 • Broken limbs block trail at 1.51 miles needs removal. (8) See Photo 5. • Sbd at 1.55 miles needs removal. • Rwk Wb at 1.55 miles. R to L. Dt on L. Needs cleaning major debris. • Dt crosses trail at 1.59 miles. Cleaning and Bn. • Nice rock steps ascending trail al at 1.64 miles. • Rwk Wb at 1.64 miles. R to L. Dt on L. Needs cleaning. • Moderate to severe erosion beginning at 1.64 miles. Bn 1.64 through 1.7 miles. • Dt on left at 1.76 needs cleaning. • Dt crosses trail at 1.78 miles. Cleaning and debris removal. • Skyline South Trail crosses at 1.78 miles. • Trail opens to road width at 1.78 miles. • Lbd crosses at 1.88 miles. (8" Dia.) Needs removal. • Unnamed path leaves on left to Rt. 138 at 1.99 miles. • Sbd at 2.01 miles. Removal and Bn. • Sbd overhanging trail at 2.02 miles (4' dia.) Bn. • Fallen tree limb blocking trail at 2.1 miles. Needs removal and bn. • Accord Path ends with its intersection with the chair lift at the Blue Hills Ski area at 2.12 miles.

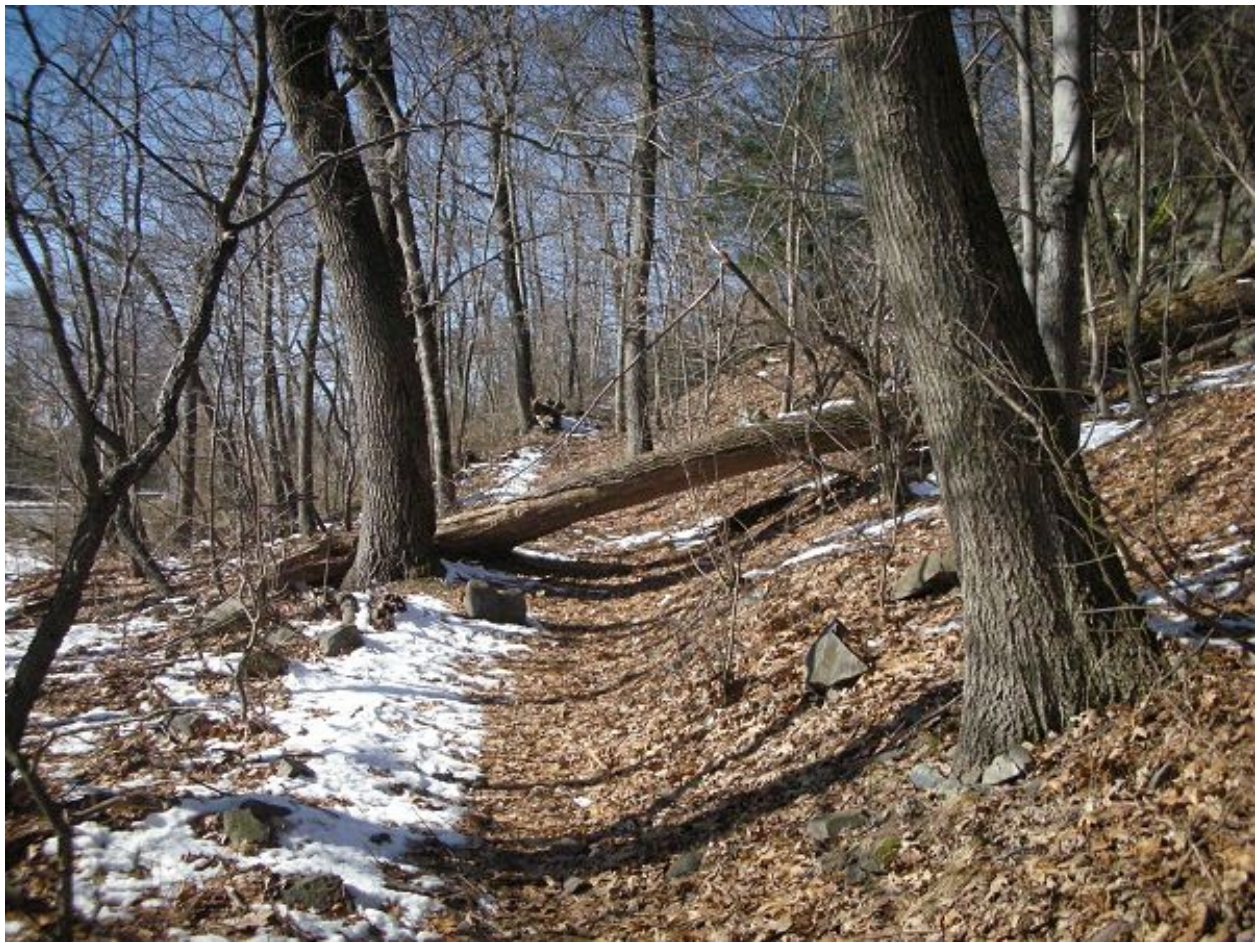
<p>needs more to open path width.</p> <ul style="list-style-type: none"> • Treadway begins ascending with bn at .48 miles. Pine boughs. • Downed limb in treadway at .49 miles. 8". Bootleg trail around limb. Should be removed. • Sbd at .52 miles. Can be stepped over. • Overhead bn at .54 miles. Bd over treadway. 2" Bow saw with pine boughs. • Bn at .55 miles. Pine boughs. • Nice rock walls confine treadway narrowly at .56 miles and open up to road width while descending through .57 miles. • Bd extending into the treadway at .15 miles. Needs to be cutback. • Downed limb in the treadway at .14 miles. Remove. • Accord Path enters the Five Corners Path at .63 miles and follows it north sharing the same treadway for 50 feet. (No FBH 1105 noted) • Accord Path leaves the Five Corners Path on the left (west) at .64 miles. This section of Accord Path is not shown on the DCR map. • Bn at .65 miles. Pine Boughs. • Bn at .68 miles. Pine Boughs. • Accord Path descends to and enters the northwest corner of a parking area on the north side of Hillside Street at .73 miles. (No FBH 1097 noted). Parking area is 1/8 of a mile west Blue Hills River Road. • At this point, Accord Path continues west while sharing the same treadway with an unnamed path paralleling Hillside Street to the Wildcat Notch Trail trailhead. This trailhead is 275 feet from the parking area and is identified with a granite marker. (No FBH 1096 noted) • Accord Path turns right (north) onto the Wildcat Notch Trail at .78 miles and shares the treadway to intersection marker 1086. • Lbd across trail .80 miles. 20" dia. • Widow maker .81 miles from trailhead, 20" dia. Remove before season. (3) • Unnamed trail enters on left. Connector to fire road and unnamed side path. • Trail opens to road width with brushing required at .82 miles. • Accord Path leaves the Wildcat Notch Trail on the left (west) at intersection marker 1086 at .84 miles. • Trail narrows to path width with Bn .87 miles from the trailhead. • Halfway Path leaves on the right (north) at intersection marker 1081 at .93 miles from the trailhead. • Trail descends into an area of minor erosion at 1.02 miles. • Brookwood Trail crosses at intersection marker 1062 at 1.03 miles. • Dt on left down to Hillside Ave. at 1.15 miles requires cleaning. • Bn at 1.16 miles. • Entering an area on moderate to severe erosion at 1.2 miles. • Dt on left down to Hillside Ave. sewer at 1.2 miles requires cleaning. LBD in dt. 12" by 12' needs to be removed. • Roofed/Stone DCR structure to right of trail at 1.27 miles. • Moderate to severe erosion continues as this trail ascends through 1.32 miles. It appears to me that this trail is intentionally used to channel runoff from the hill on the right of the trail. There is Rwk on the side of the trail in some areas to keep the runoff on the trail and divert it into Dt

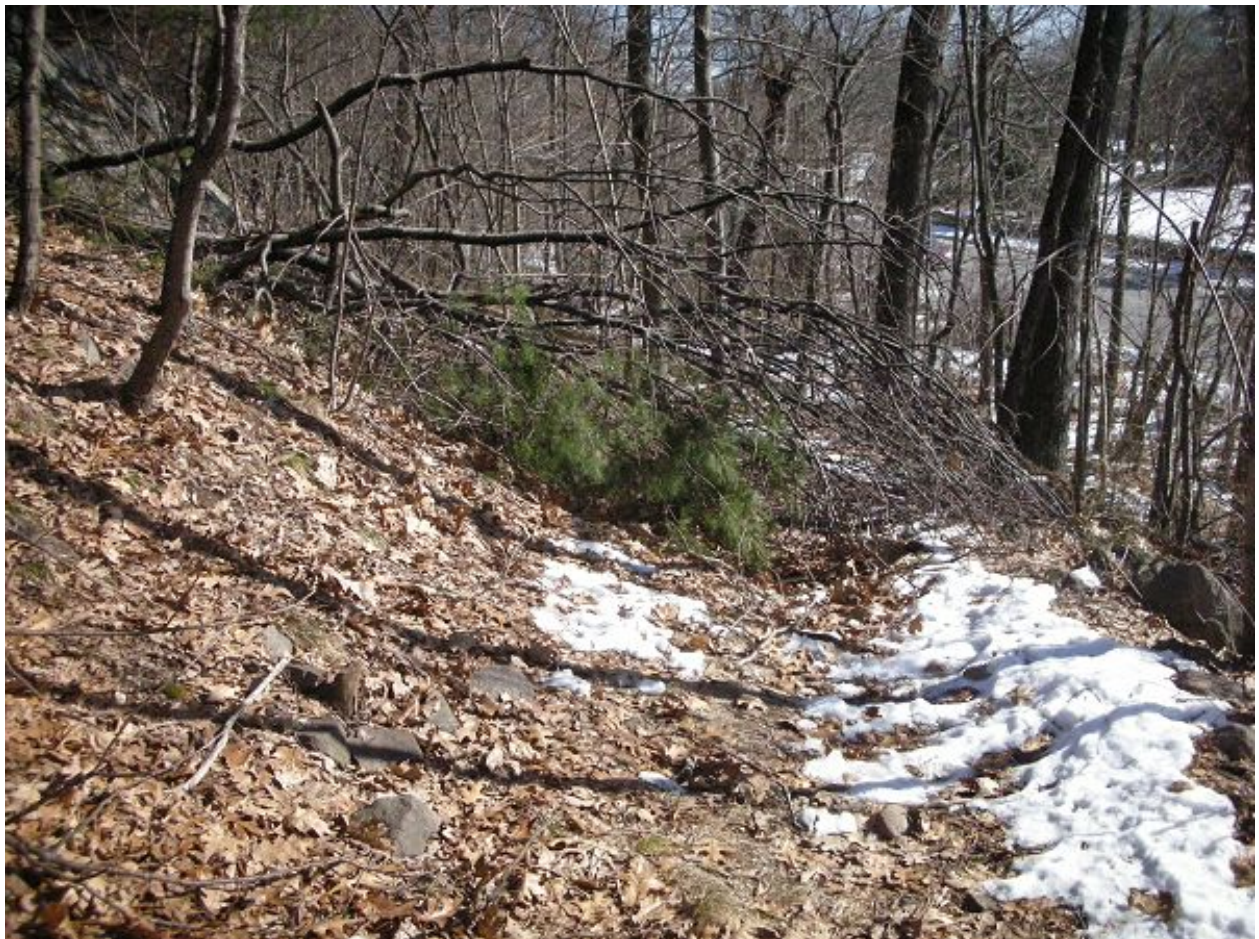
<p>miles would minimize treadway erosion through this area however this would be a major undertaking. See Photo. (5)</p> <p>6. Trail descends into an area of moderate to severe erosion at 1.43 miles. Again it appears to me that this trail is intentionally used to channel runoff from the hill on the right of the trail. Rkw on left. (6)</p>		
DISTANCES TO MAJOR INTERSECTIONS	<ul style="list-style-type: none">• Hillside Street Trailhead to - Houghton Hill Trail (FBH) crosses at intersection marker 1151 - .09 miles• Hillside Street Trailhead to Houghtons Path crosses - .22 miles.• Hillside Street Trailhead to Coon Hollow Path crosses - .32 miles.• Hillside Street Trailhead to the Five Corners Path - .63 miles.• Hillside Street Trailhead to the northwest corner of a parking area on the north side of Hillside Street - .73 miles.• Hillside Street Trailhead to Accord Path turns right (north) onto the Wildcat Notch Trail - .78 miles• Hillside Street Trailhead to Accord Path leaves the Wildcat Notch Trail on the left (east) at intersection marker 1086 - .84 miles.• Hillside Street Trailhead to Halfway Path leaves on the right at intersection marker 1081 - .93 miles.• Hillside Street Trailhead to Brookwood Trail crosses at intersection marker 1062 - 1.03 miles.• Hillside Street Trailhead to Skyline South Trail crosses - 1.78 miles.• Hillside Street Trailhead to Accord Path ends with its intersection with the Blue Hills Ski area - 2.12 miles.
