# TRAIL ASSESSMENT FORM

<b>Doc. #</b>	1024	<b>Trail Name</b>	Carberry Path North	<b>Trail Type:</b>	<b>Wide - M</b>	<b>Condition</b>	Good
<b>Route:</b>		Walcott Path 1100 – Park Boundry					
<b>Recent Weather:</b>		Rainy today – No snow on trail					
<b>TRAIL LANDMARKS</b>		<ul style="list-style-type: none"> <li>• Carberry Path trailhead leaves the Border Path on the left, 20 feet north of the Border - Wolcott Path intersection at intersection marker 1100. Intersection is accessed via Wolcott Path east and is .6 miles from the Trailside Museum North parking area.</li> <li>• Wide treadway turns into a footpath at 100 feet and enters a large meadow at this point.</li> <li>• Cv crosses under treadway at .1 miles in streambed. Rkw/cinderblock construction on both sides with cement pipe (24"). Streambed is loaded with debris in both wells with tree growing out of streambed on right. Needs cleaning. (1)</li> <li>• Bn at .16 miles. Apple trees need to be cutback. Bow saw work (2) (See photo below)</li> <li>• Carberry Path ends at the park boundary and private gate at .18 miles. Private property and residence lies beyond gate.</li> </ul>

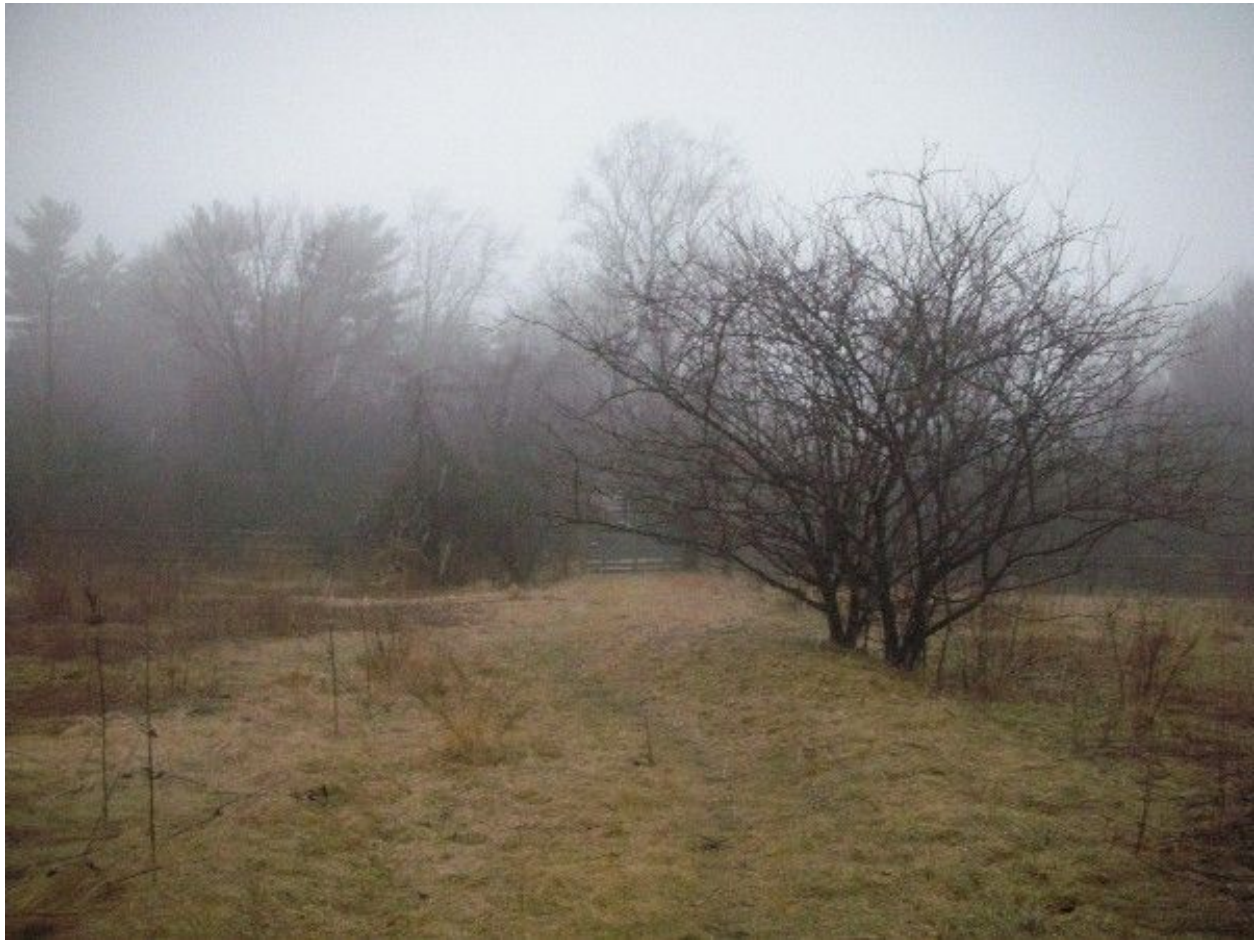
<b>MINOR PROBLEM AREAS</b>		(1) Cv crosses under treadway at .1 miles in streambed. Cv wells are loaded with debris with tree growing out of well on right. Needs cleaning. (2) Bn at .16 miles. Apple trees need to be cutback. (Photo attachment CP1)					
<b>MAJOR PROBLEM AREAS</b>		<ul style="list-style-type: none"> <li>• None noted</li> </ul>					
<b>DISTANCES TO MAJOR INTERSECTIONS</b>		<ul style="list-style-type: none"> <li>• Trailhead 20 feet north of intersection marker 1100 to Park Boundary - .18 miles</li> </ul>					
<b>Report prepared by:</b>		Ken Jones			<b>Assessment date:</b>	2/5/2008
