TRAIL ASSESSMENT FORM

Doc. #	3003	Trail Name	Bouncing Brook Path	Trail Type:	M	Condition	Good
Route:		From 'y' at Squamaug Notch Path to gate at rte.28					
Recent Weather:		Clear, no precipitation in at least a week					
TRAIL LANDMARKS		<p>Trail starts apparently at a 'y' intersection with Squamaug Notch Path, between 3163 and 3152, and travels generally E and SE. Easiest access is from Wood Road, via Romari Trail and Squamaug Notch Path. Starting from the 'y':</p> <p>10 yd Partial lbd(1) 150 yd Lg. lt (2) 160 yd sm lt(3) 230 yd 3152 with Wampatuck Path 261yd 3151 right at 'y' missing mk(4) 272 yd S side of trail du 354 yd old nf wb not really needed not an obstruction 502 yd 3130 int Curve (trail?path?no desig.on map)on right part of red dot loop—red dots are new and visible on BB trail 529 yd 12" corr plastic cv (5) 539 yd nf wb(not an obst) (6) 578yd 24" cp cv fc(7) .58 mi nf wb(nn)(not an obstruction) .59 mi 3085(mk need new)nf cv(8) .60 mi nf armored water crossing (9) .61 nf wb rr tie (10) .62 3073 int w/ Side Notch Path on N side .64 int w/Lee Path (11) .64 ditch on N side leading W into 12" cp cv (12) (Swamp/vernal area on S side of trail) .68 N side large du (13) .70 fc

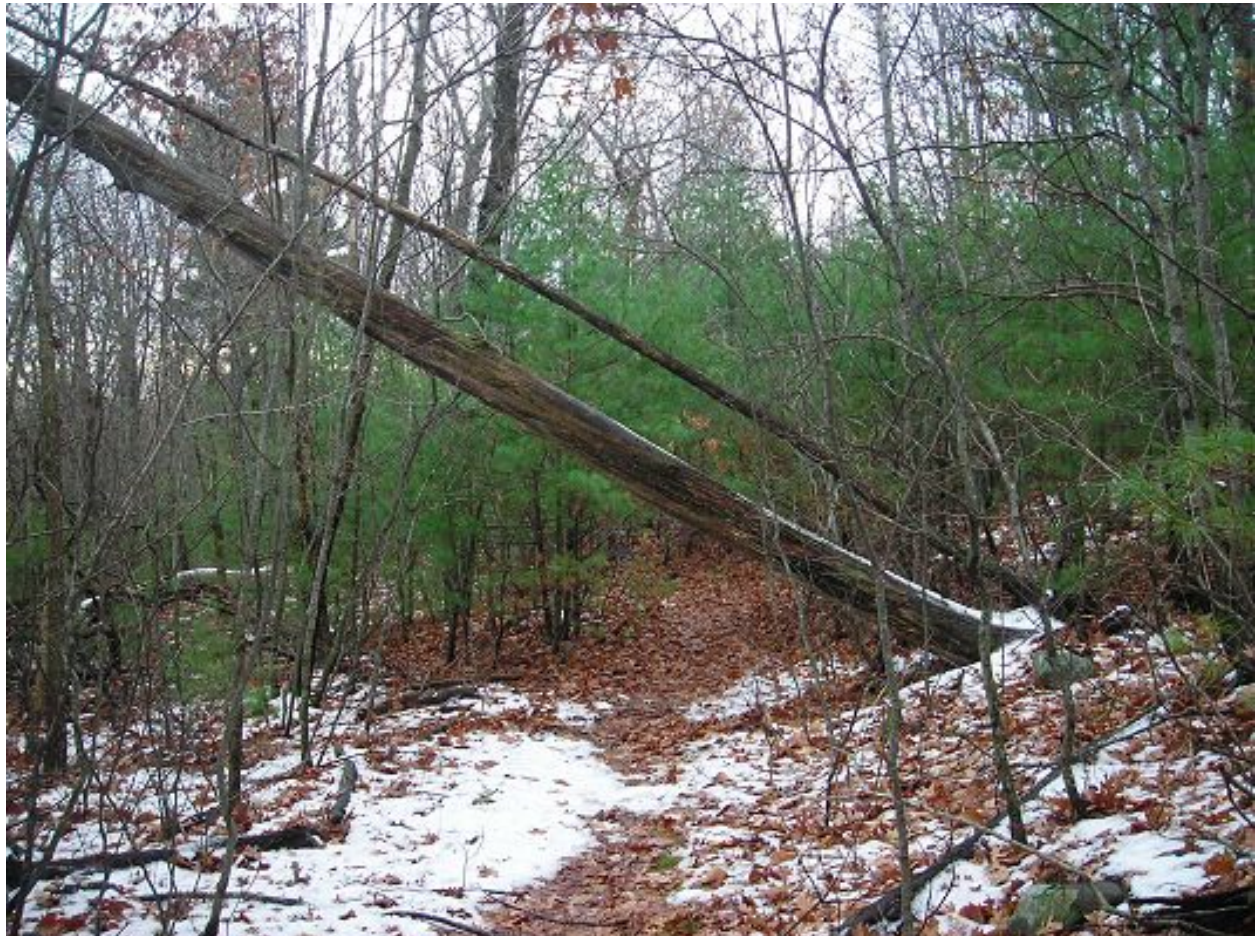
MINOR PROBLEM AREAS		<p>Trail itself needs no work. Is wide enough and accessible enough for vehicle passage. No cutbacks necessary at this time, but may need sapling cutbacks in some places in 2-3 years to maintain width. A lot of culvert and ditch cleaning needed that could be done in sections by crews of 2-3 people. Not heavy work, just need fire rakes, shovels, maybe a pick, and wheel barrow for removed duff and leaves.</p> <p>(4) mk replacement (5) cv clogged with leaves. Needs cleanout</p>

(6) minor rkw not a high priority, but could replace the nf wb (7) ditch leading up to needs cleaning out (8) hidden/no pipe visible, need dig out for proper fc (11) no mk-recommend one (12) need clean out all (14) cv needs cleaning out. trail puddles here in wet seasons, need to trench out the sides of trail to drain (15) need mk (16) needs cleaning along with ditches leading up to (17) needs cleaning along with ditches leading up to (18) no mk, may be 3023? (19) needs cleaning along with ditch on S side		
MAJOR PROBLEM AREAS	(1) chainsaw (2) chainsaw –hard hats (3) chainsaw and manually move (9) needs more rkw and ntd heavily silted both sides (10) rotted needs replacing and ditch leading to needs cleaning (13) lg dead trees on top edge that will fall onto trail 1-2 years		
DISTANCES TO MAJOR INTERSECTIONS	Trail length 1.05 mi.		
Report prepared by:	Steve Cobble	Assessment date:	01/09/08
