# TRAIL ASSESSMENT FORM

| <b>Doc. #</b> | 2001 | <b>Trail Name</b> | Skyline Trail East<br>Hillside Street to<br>Route 28 | <b>Trail Type:</b> | <b>Wide - M</b> | <b>Condition</b> | Good |

| <b>Report prepared by:</b> | Ken Jones | <b>Assessment date:</b> | 2/17/2008 |

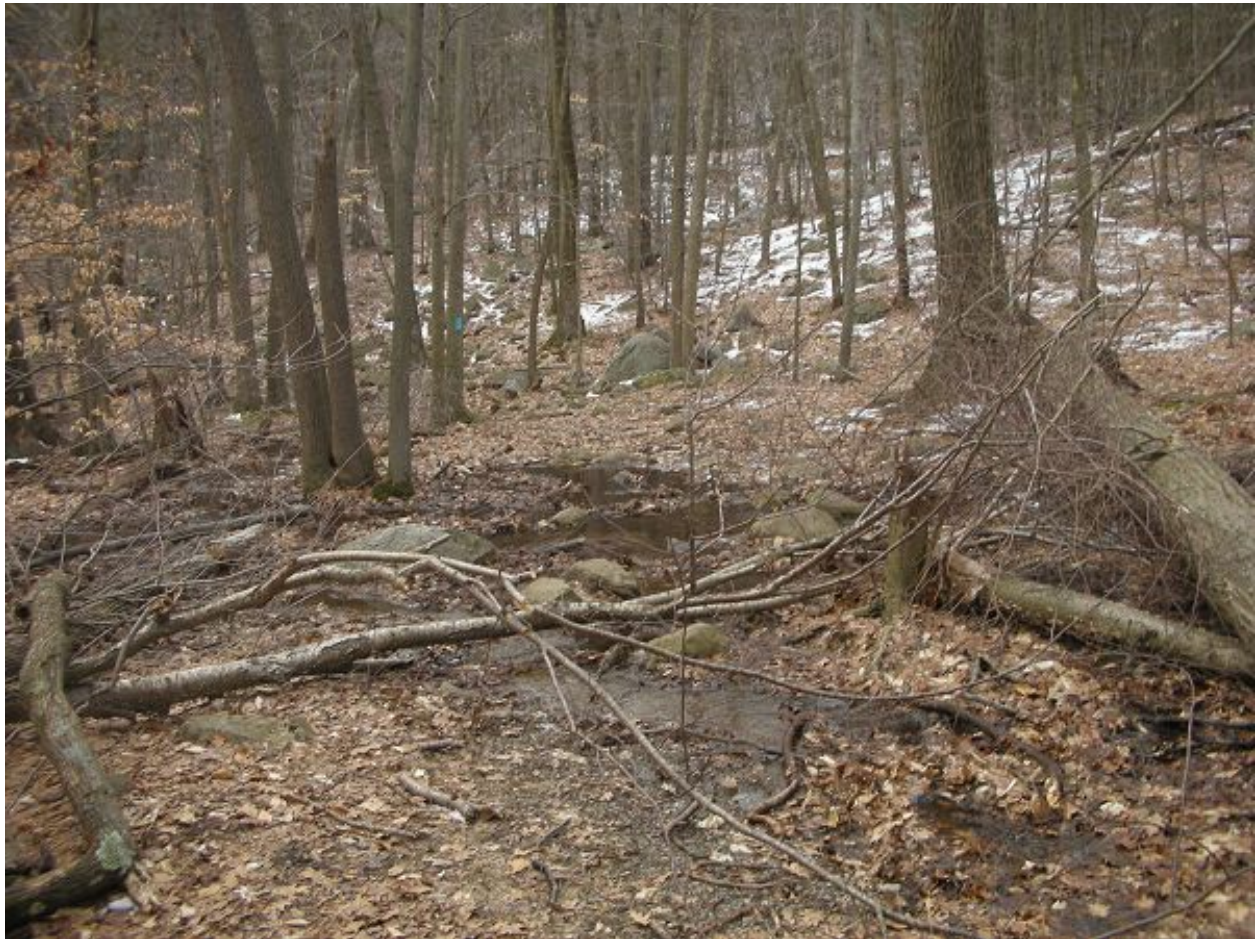
- Skyline leaves the Dark Hollow Path on the right at .83 miles.
- Bn at .84 miles with downed tree limbs. Bow saw and lopper work.
- Treadway enters an area of moderate runoff at .84 miles. Possible bog bridge location. (3) (Photo attached SLE01).
