TRAIL ASSESSMENT FORM

Doc. #	5003	Trail Name	Acton Path West Revision 1	Trail Type:	Wide - M	Condition	Good
Route:		Reservation Boundary route 24 – 5395 –Swamp Trail – 5321 - 5175					
Recent Weather:		Rain last 24 hours, Cloudy in the 30's					
TRAIL LANDMARKS		<ul style="list-style-type: none"> Trailhead is located at the reservation boundary and leaves from the route 24 highway fence. Treadway at this point is the heavily brushed area of the gas pipeline and is blazed on the right and left with blue surveyor tape. Hemlock Road crosses at 225 feet. Cv crosses under a portion the treadway at .2 miles. Steel 24" pipe. Cv crosses under a portion the treadway at .24 miles. Steel 24" pipe. Cv crosses under a portion the treadway at .29 miles. Steel 24" pipe. Treadway enters an intersection with the Swamp Trail entering on the right (north) at .35 miles. An unnamed footpath leaves on the left (south) to the reservation boundary. At this point Acton Path shares the same treadway as the Green Dot Loop Trail and continues to head west following the green dot blazes. Cv crosses under treadway at .37 miles. L to R. 14" corrugated PVC pipe. Dt on left for 100 yard feeding cv. Cv crosses und

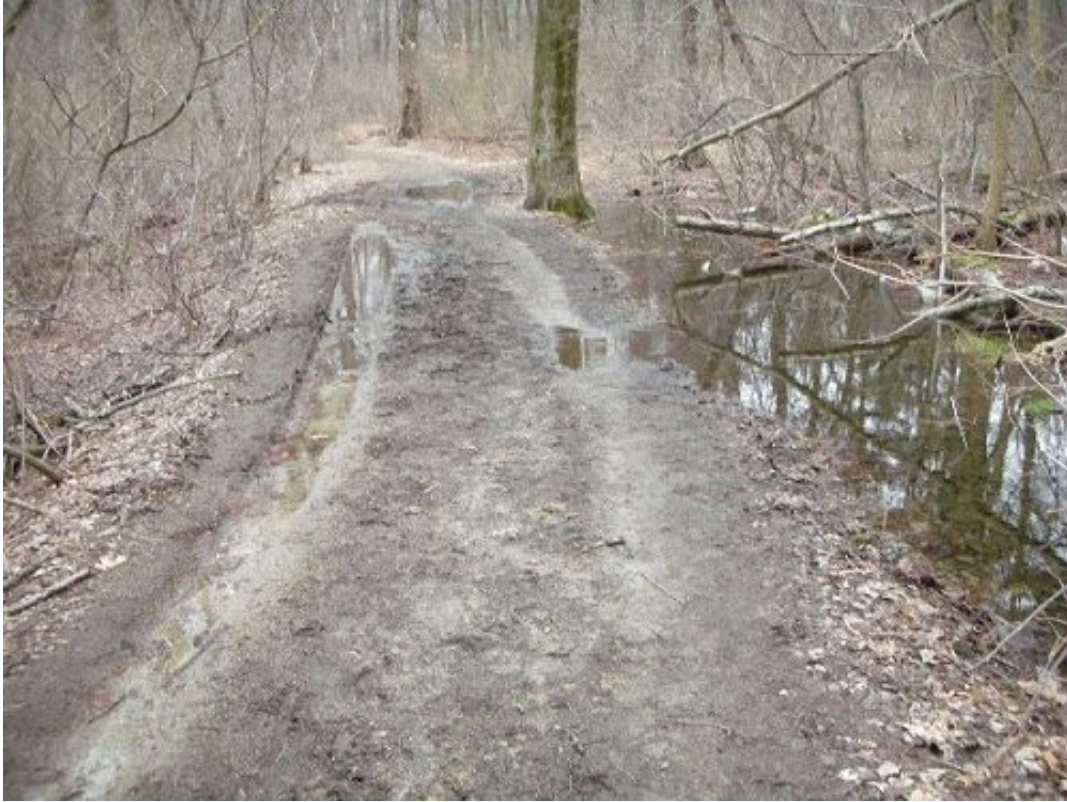
pgdl1:

MINOR PROBLEM AREAS	<ol style="list-style-type: none"> 1. Runoff in the treadway at .91 miles. 2-3 inches deep. Possible cv location. (1) See photo pgdl1. 2. Cv crosses under treadway at 1.35 miles. Pipe crushed on left. Needs additional dt on left to reduce runoff in the treadway (2). 		
MAJOR PROBLEM AREAS	<ul style="list-style-type: none"> • None noted 		
DISTANCES TO MAJOR INTERSECTIONS	<ul style="list-style-type: none"> • Route 24 reservation boundary to Hemlock Road - 225 feet • Route 24 reservation boundary to the Swamp Trail (FBH map) - .35 miles. • Route 24 reservation boundary to entry road to the AMC Camps - .85 miles • Route 24 reservation boundary to Fishermans Beach at intersection marker 5321 - .97 miles. • Route 24 reservation boundary to Acton Path ends at intersection marker 5175 - 1.83 miles. 		
Report prepared by:	Ken Jones – 4/12/08	Assessment date:	4/7/2008
