TRAIL ASSESSMENT FORM

Doc. #	4006	Trail Name	Fox Hill Path North	Trail Type:	Wide - M	Condition	Good
Route:		Chickatawbut Road – Indian Camp Path					
Recent Weather:		Rain within last 24 hours. Sunny in the 30's					
TRAIL LANDMARKS		<ul style="list-style-type: none"> Trailhead is located on the north side of Chickatawbut Road across from the east end of the Blue Hills Reservoir and .7 miles west of the Chickatawbut Road entry gate on Willard Street. Trail leaves 50 yards west of the pipeline at a granite marker labeled Fox Hill Path. Trail begins as a footpath as opposed to a wide path noted on the DCR map. Bn at entry into woods. Lbd across treadway at 250 feet. Chainsaw removal. (1) (see photo fhp1) Bd to left of treadway at 360 feet. Pull off treadway with 2 people. Bd crosses treadway at 450 feet. Cutback. Bow saw. Treadway opens up to road width at .1 miles ascending Fox Hill. Bn at .13. Downed limbs. Bow Saw. Bn at .14. Downed limbs. Loppers. Bn at .19. Downed limbs. Loppers. Treadway crosses the summit of Fox Hill at .22 miles with lunch rock and cairn to the right of the treadway. Unnamed path leaves on the left at .24 miles. Old FBH maps show intersection marker 4096 at

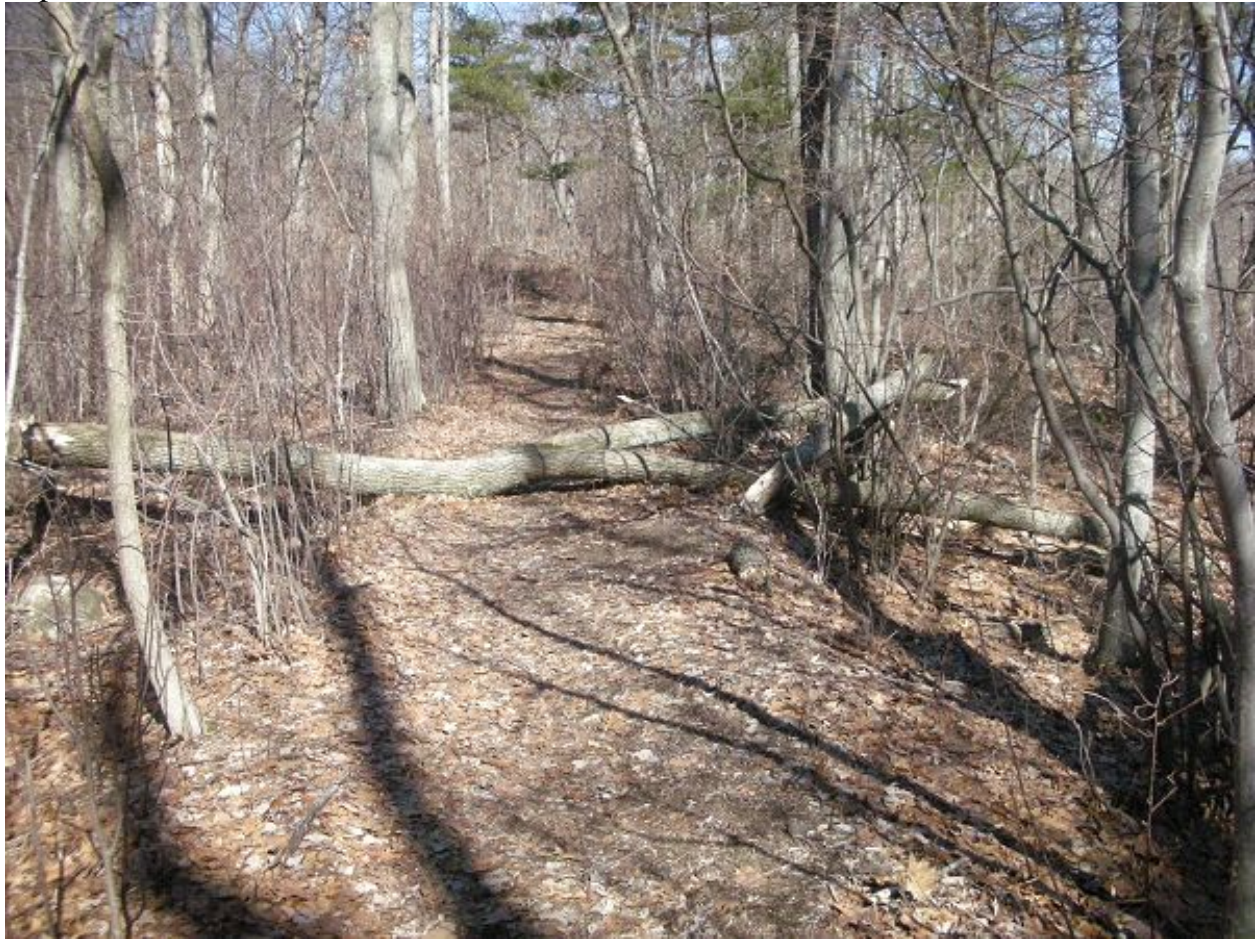
Fhp1:

MINOR PROBLEM AREAS		<ol style="list-style-type: none"> Lbd across treadway at 250 feet. Chainsaw removal. (1) (See photo fhp1) Impairs fire road access. Rkw wb at .43 miles. R to L. Section of minor erosion follows. Wb is not effective and needs to be dug out and dt on left. (2) Rkw wb at .44 miles. L to R. Section of minor erosion follows. Wb is not effective and needs to be dug out and dt on right. (3) 					
MAJOR PROBLEM AREAS		<ul style="list-style-type: none"> None noted 					
DISTANCES TO MAJOR		<ul style="list-style-type: none"> Chickatawbut Road to Indian Camp Path - .47 miles.
