TRAIL ASSESSMENT FORM

Doc. #	4009	Trail Name	Indian Camp Path West	Trail Type:	Wide - M	Condition	Good
Route:		Green Dot Loop – Wampatuck Road - 4155 – 4135 – 4120 – 4090 – 4083 Sawcut Notch Path					
Recent Weather:		Rain last 24 hours, Light rain in the 30's					
TRAIL LANDMARKS		<ul style="list-style-type: none"> • For the purpose of this trail description, Indian Camp Path will be surveyed using both the DCR and FBH maps. There are some sections of this trail that do not appear on the DCR maps and I feel they should be included to extend this fine walk in the woods. The old FBH maps refer to this trail as the Indian Camp Trail. • The trailhead is located .03 miles west of intersection marker 4202 on the south side of the southern section of the Green Dot Trail Loop. Trailhead is approximately .43 miles from the Shea Rink parking area. Intersection marker 4202 is a bootleg marker (magic marker) on a 4x4 wooden post and should be changed to a standard DCR marker. (1) • Trail leaves this section of the Green Dot loop at blue diamond shaped wooden blaze nailed to a tree. This section of the trail uses this type of blazing until its intersection with Wampatuck Road. Old FBH maps no

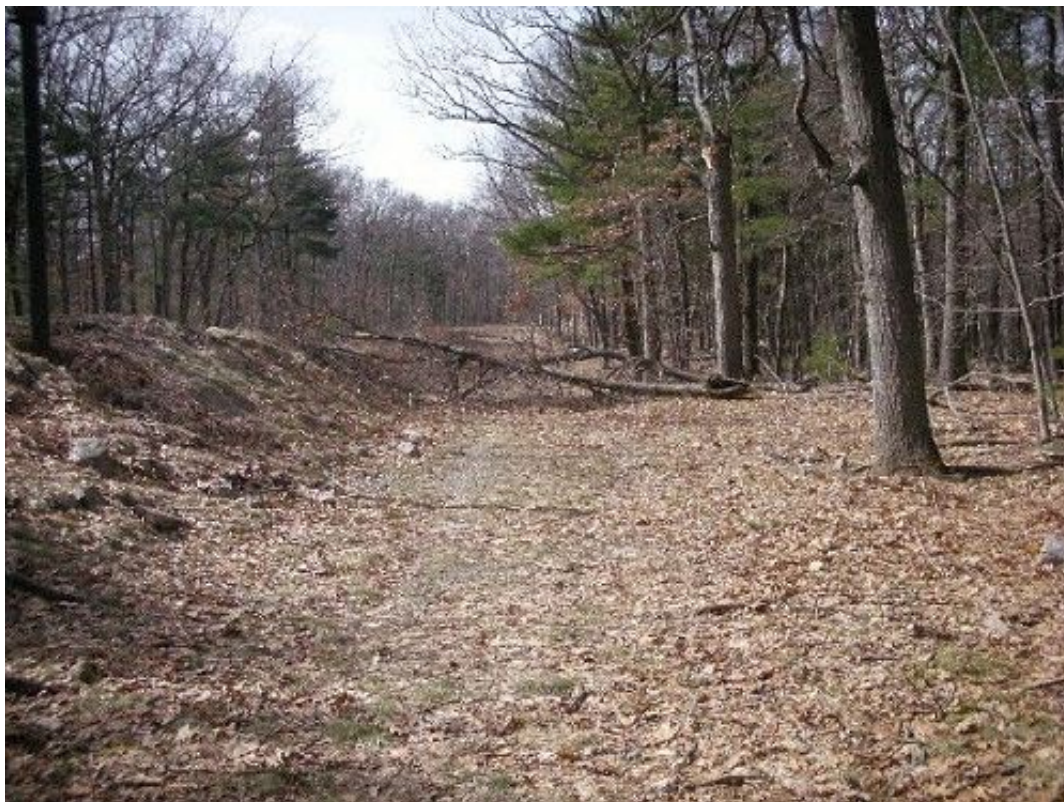
GDP1:

<p>treadway has 2' of water on it. Needs to be dt into woods on right. (2) (see photo gd1)</p> <ul style="list-style-type: none"> • Skyline crosses at intersection marker 4155 at .56 miles. Signage on tree denotes Skyline West to Great Blue Hill and Green Dot to St. Moritz Ponds. • Lbd across treadway at .59 miles. 8" dia. Chainsaw. Blocking Fire road. (3) (See photo gd2) • Cv to the left of the treadway at .62 miles under pipeline. Cement construction with 2 pipes half full of debris. Water not draining and treadway has 2' of water on it. Needs to be dt into woods on right. • Fire road partially blocked by new tree growth at .64 miles. Cut back. • Cv to the left of the treadway at .70 miles under pipeline. Cement construction with 2 pipes half full of debris. Water not draining and treadway has 2' of water on it. Needs to be dt into woods on right. • Bn at .71 miles. • Unnamed path leaves on left at .72 miles. • Cv under treadway at .73 miles. Cement work to right of treadway. • Cv to the left of the treadway at .75 miles under pipeline. Cement construction totally impacted. Treadway has 2' of water on it. Needs to be dt into woods on right. • Pipeline Trail (Craggs Trail (FBH) crosses at intersection marker 4135 at .76 miles. • Bn at .78 miles. Lopper work. • Bn needed .87 through .93 miles. • Cv under treadway in streambed at .96 miles. 24" clay pipe. Debris in rkw well on R and L to be cleaned. • Unnamed path leaves on right at intersection marker 4120 at .97 miles. Road width connector to Craggs Foot Path. Old FBH maps show this as the Furnace Brook Trail. • Bn from .98 to 1.30 miles. Small trees extending into treadway. • Very minor erosion ascending hill at 1.09 miles. • Unnamed path enters on left at 1.23 miles. Road width path to Fox Hill. • Two inches of standing water in treadway at 1.24 miles • Unnamed path leaves on left at 1.32 miles. Great Dome Foot Path as noted on old FBH maps. • Treadway enters an intersection at intersection marker 4090 at 1.34 miles. Signage on tree denotes the Green Dot trail leaving on a footpath to the right (northeast). Indian Camp Path continues straight (northwest) at road width to intersection marker 4083 as noted on old FBH maps. Pleasant Trail (FBH) leaves on the left at road width to intersection marker 4043 as noted on old FBH maps. • Bn 1.37 through 1.39 miles. • Unnamed path enters on the left at 1.40. Spur path to intersection marker 4043. (Pleasant Trail FBH map) • Cv under treadway in streambed running R to L at 1.40 miles. Rkw on R and L w/ 18" corrugated PVC pipe. Rkw wells require cleaning. • Bn at 1.41 miles. • Bn at 1.44 miles. • Unnamed path leaves on right at 1.46 miles to intersection marker 4091. • Bn at 1.47 miles. • Craggs Foot Path enters on right at 1.48 miles.
