TRAIL ASSESSMENT FORM

Doc. #	4011	Trail Name	Pine Tree Brook Path North	Trail Type:	Wide - M	Condition	Good
Route:		Trailhead from Ridge Path – 4084 – 4073 – HQ Path/Pipeline					
Recent Weather:		Rain last 24 hours, Light rain in the 30's					
TRAIL LANDMARKS		<ul style="list-style-type: none"> Trailhead surveyed is located on the right side (east) of Ridge Path and leaves 40 feet from the Ridge Path trailhead at the fire gate This is a connector path to the main section of Pine Tree Brook Path. Trail is also accessible from Chickatawbut Road as noted on the map although it has not been used very much and is overgrown. Two boulders at the guardrail mark his access. No FBH 4092 intersection marker noted. <ul style="list-style-type: none"> Ridge Path leaves from the north side of Chickatawbut Road at a fire gate and granite marker labeled Ridge Path. It is located .52 miles from the point where the Skyline crosses Chickatawbut Road. Trail begins as a connector foot path paralleling Chickatawbut Road. Bn at 150 feet. Pine Tree Brook Path enters on right at 220 feet to Chickatawbut Road. Lbd crosses treadway at 290 feet. Several large limbs need to be removed as treadway bootlegs aro

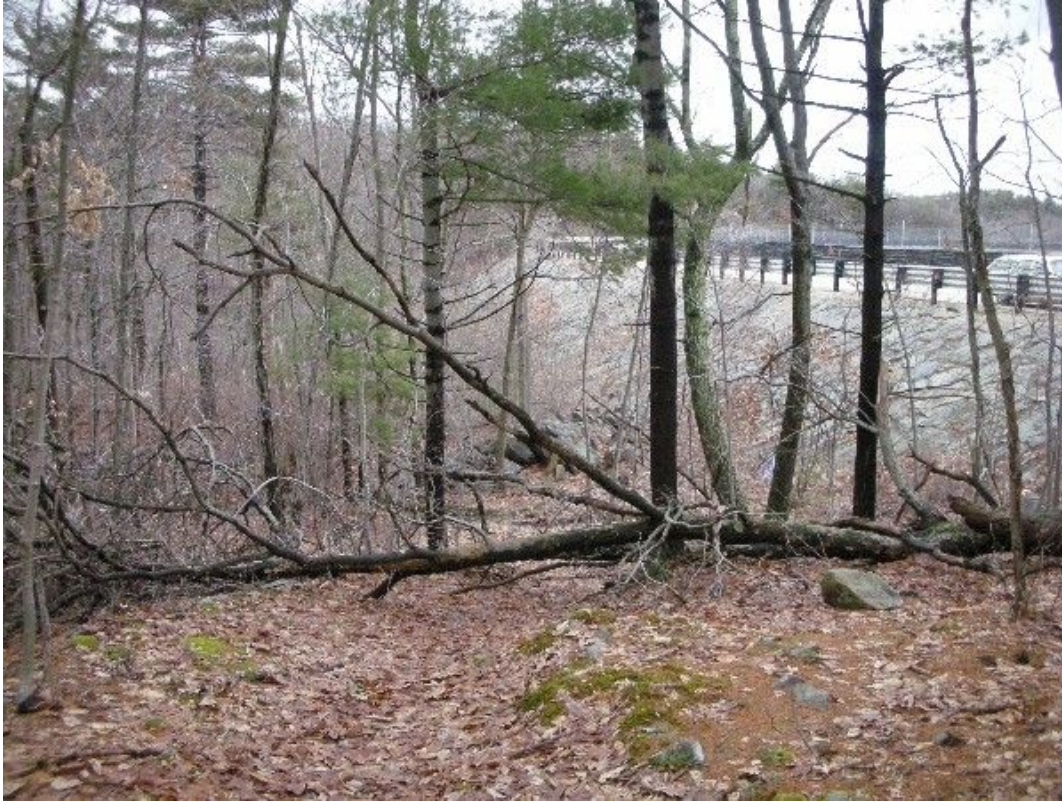
PTB1:

MINOR PROBLEM AREAS	<ol style="list-style-type: none"> 1. Lbd crosses treadway at 290 feet. Several large limbs need to be removed as treadway bootlegs around limbs. Chainsaw. See photo PTB1. (1) 2. Possible impacted cv under treadway at .21 miles. Runoff entering and exiting under treadway at buried rkw however no evidence of a cv could be found. Needs to be investigated.(2) 3. Intersection marker 4084 noted on right side of treadway however no trail exiting on right as noted on the map could be found. Either trail has become obscure or intersection marker moved as noted previously above at an unnamed path. (3) Needs further investigation. 4. Unnamed path (Great Dome Foot Path FBH) leaves on the right at .43 miles at footpath width. No intersection marker 4073 could be found. (4) 5. Pine Tree Brook path ends with its intersection with Headquarters Path/ Pipeline at .7 miles. There is a bootleg intersection marker 4049 on a tree to the left of the treadway. (5)
