TRAIL ASSESSMENT FORM

Doc. #	4012	Trail Name	Sassaman Path North	Trail Type:	Wide - M	Condition	Poor
Route:		Trailhead from Pasture Run - 4047 – 4048 – 4043 – 4023 - 4042					
Recent Weather:		Rain last 24 hours, Light rain in the 30's					
TRAIL LANDMARKS		<ul style="list-style-type: none"> • Sassaman Path leaves from the east side of the Pasture Run Trail approximately 1/8 of a mile north of Chickatawbut Road. • Bn at 100 feet Debris in treadway. • Two cut logs in treadway at .15 miles. Remove. • Treadway enters a 4-way intersection at .17 miles. Intersection not noted on FBH or DCR maps. Intersection created from a not shown, road width connector from Ridge Path to Sassaman Path. Ridge Path enters on right and continues on right while Sassaman Path enters on left and continues left. This intersection should have appropriate signage installed to eliminate confusion. (5) • Bn at .17 miles. • Bn at .2 Miles. At this point treadway begins descending into an area of runoff and minor erosion that continues to the Pipeline. • Bn at .22 miles. • Ridge Path enters on the right at intersection marker 4047 at .23 miles. Downed limb needs to be removed. • Bn at .27 • Sassaman Path enters t

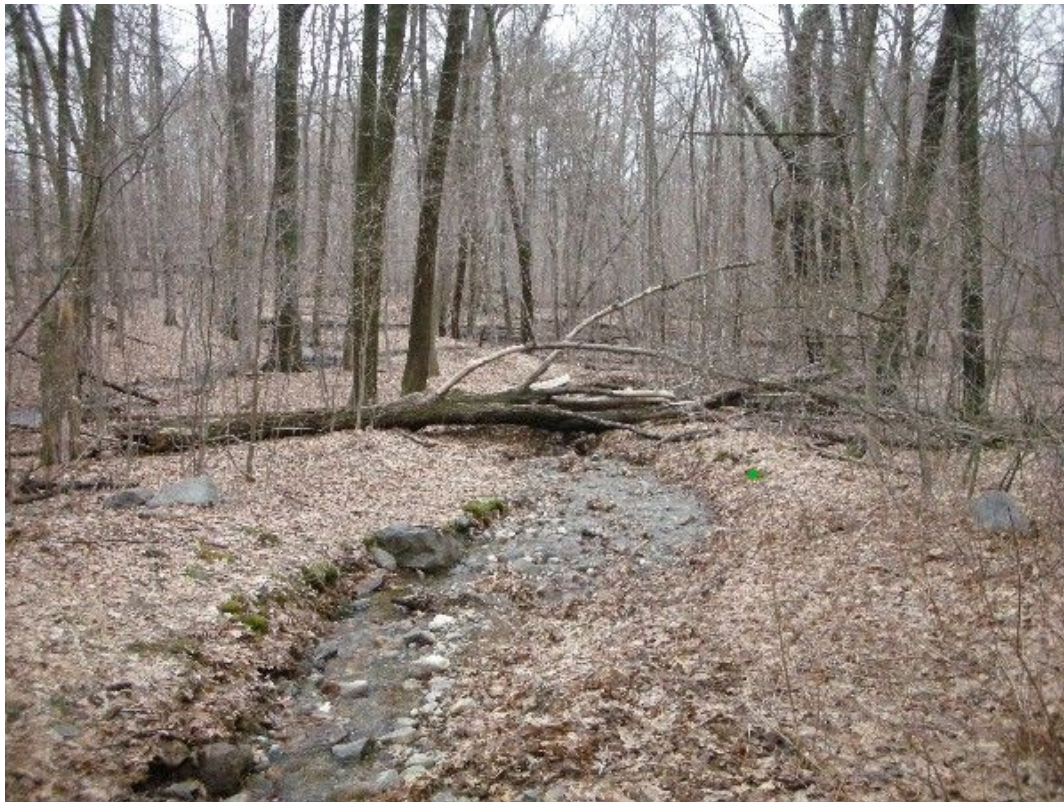
SP1:

MINOR PROBLEM AREAS	<p>1. Lbd crosses the treadway at .40 miles. Five limbs 8-14". Chainsaw. (1) Photo SP1.</p> <p>4. Bn from .63 through .64 miles. Three Lbd cross the treadway. 24" dia. Chainsaw removal. Can be stepped over. (4) Photo SP4.</p> <p>5. Treadway enters a 4-way intersection at .17 miles. Intersection not noted on FBH or DCR maps. Intersection created from a not shown, road width connector from Ridge Path to Sassaman Path. Ridge Path enters on right and continues on right while Sassaman Path enters on left and continues left. This intersection should have appropriate signage installed to eliminate confusion. (5)</p>
MAJOR PROBLEM AREAS	<p>2. Cv under the treadway at .42 miles. Totally impacted and ineffective. Rkw construction on right. No entry noted on left. Runoff goes around cv to the left of treadway and washes back across treadway at a lbd acting as a wb. (2) Photo SP2.</p> <p>3. Lbd w/bn at .47 miles. Cannot locate treadway until around this area. Treadway still in streambed (3) Photo SP3.</p>
