TRAIL ASSESSMENT FORM

Doc. #	4017	Trail Name	Quarries Foot Path North	Trail Type:	Wide and Narrow - M	Condition	Good
Route:		Wampatuck Road - 4238 – <u>4238</u> – 4237 – Ricciuti Drive – 4229 – Granite Railroad Historic Site					
Recent Weather:		No rain last 60 hours, Sunny in the 30's					
TRAIL LANDMARKS		<ul style="list-style-type: none"> • Trailhead leaves from the west side of Wampatuck Road at a fire gate and granite marker labeled Quarry Foot Path. Trailhead is located approximately .1 mile west of the Bunker Hill/Wampatuck Road intersection. For the most part, this trail is primarily blazed with white rectangles unless otherwise noted in the survey. • Treadway leaves at road width with bn. • Cv crosses under the treadway in streambed at 133 feet. Rkw/cement construction w/ 30' cement pipe. Bn. • Cv crosses under the treadway at 164 feet. Rkw/cement construction w/ cement pipe. Bn. • Possible impacted cv under treadway at 232 feet. Evidence in treadway however no pipes were noted. (1) • Possible impacted cv under treadway at 270 feet. Collapse rwk to right of treadway however no pipes were noted. (2) • Treadway turns sharp left at 357 feet at private property. Treadway bec

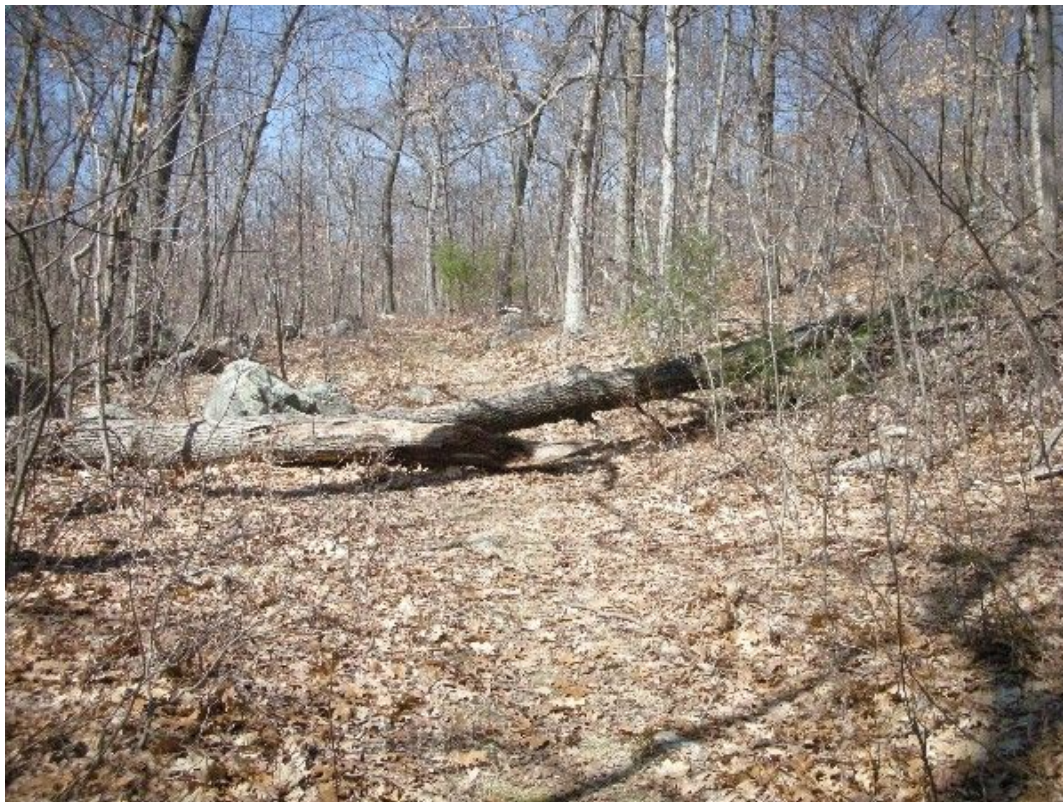
Qfp1:

MINOR PROBLEM AREAS	<ol style="list-style-type: none"> 1. Possible impacted cv under treadway at 232 feet. Evidence in treadway however no pipes were noted. (1) 2. Possible impacted cv under treadway at 270 feet. Collapse rwk to right of treadway however no pipes were noted. (2) 3. Lbd at .13 miles. Two limbs 18". Chainsaw. Needs to be cutback. (3) See photo qfp1. 4. Lbd crosses treadway at .22 miles. Previously chain-sawed however more required with extensive bn. (4) See photo qfp2. 5. Lbd crosses the treadway as widow maker at .7 miles. Previously chain-sawed with more to be done. (5) See photo qfp3. 6. Unnamed path leaves on left to Ricciuti Drive at <u>additional Intersection marker 4328</u> at .74 miles. (6) 7. Unnamed path leaves on the right at .89 miles at road width to intersection marker 4236. Marker could not be found however there is a repainted DCR type marker on a tree labeled Tara White. In this location? (7) 8. Unnamed path leaves on left to at Bootleg intersection marker 4229 at 1.24 miles. DCR map shows this a wide path however the FBH map shows this as a connector trail to the Quarry Foot Path. (8) <ul style="list-style-type: none"> • Editorial Comment – This was a wonderful walk however the continuation of the white rectangular blazes end to end would have made route finding much easier and make for a more enjoyable walk
