TRAIL ASSESSMENT FORM

Doc. #	4005	Trail N	lame	Green Dot Loop – Shea Rink to Skyline Trail	Trail Type:	Wide - M	Condition	Good	
Route:			Shea Rink – 4205 - 4202 – Wampatuck Rd.– 4155 – 4135 – 4120 – 4090 – 4095 – 4142 – 4145 – 4151 – 4174 – 4184 - Wampatuck Rd – Skyline Trail.						
Recent Weather:			No rain last 48 hours, Sunny in the 40's						
Recent V TRAII LAND	1		No i		in the 40's oop trail utiliz The Indian Covever there are arkers and the as I feel pertin at the south en on information the trailhead it hares the same as Skyline Tra dth. Additional readway is not abed over Min way identifies (2) right around to the treadway a cv is being do itz Pond. Ditce as cetion with the the An unname on to the St. Muld not be loce an pipeline state the located on 4 miles. Cemen ascends over of	zing many tracemp Path and e many other old FBH manent. It is additionate treadway and blazing and to blazed until ichiello Bridgichiello Brid	ails in the 400 d Crags Foot resections of caps. They will a Rink parking it is blazed willy blazed with sthe Skyline at 473 feet. It signage requestions approximately of South St. It is a cv running so Cement the treadway be incorporated by the straight.

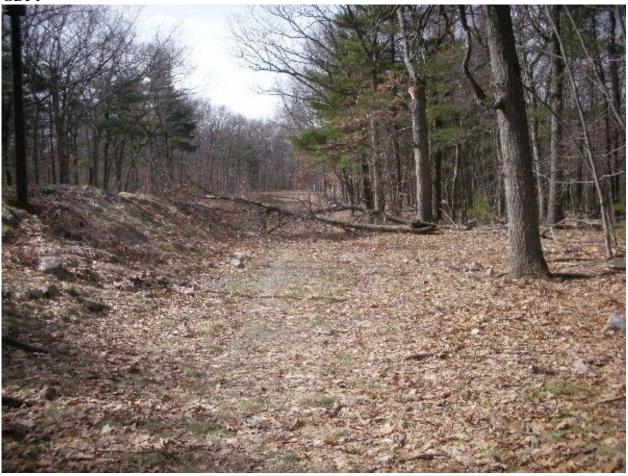
GDP1

- Treadway continues at fire road width and continues to parallel the pipeline.
- Sbd across the treadway at .91 miles. 4". Bow saw.
- Cv to the left of the treadway at .92 miles under pipeline. Cement construction with 2 pipes half full of debris. Water not draining and treadway has 2' of water on it. Needs to be dt into woods on right. (6) (see photo gd1)

• Lbd across treadway at 1.0 miles. 8" dia. Chainsaw. Blocking Fire road.
	(7) (See photo gd1)
	• Green Dot trail leaves intersection 4090 on the right (northeast) at 1.75
	miles at footpath width. Significant cleanup to be completed for next .15 miles (8)

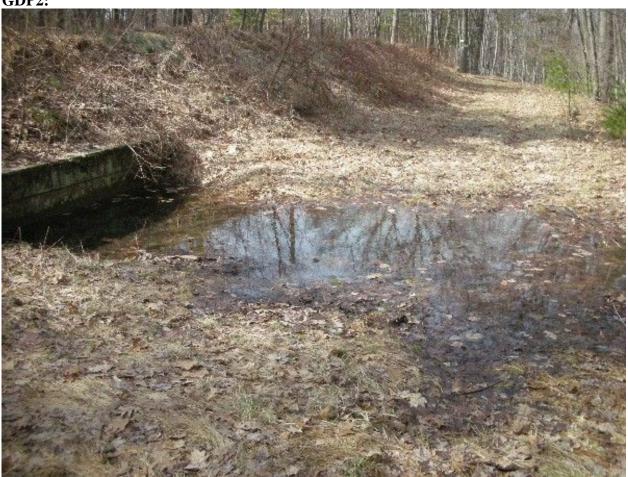
GDP2:

- Skyline crosses at intersection marker 4155 at .97 miles. Signage on tree denotes Skyline West to Great Blue Hill and Green Dot to St. Moritz Ponds.
- Lbd across treadway at 1.0 miles. 8" dia. Chainsaw. Blocking Fire road. (7) (See photo gd2)

• Cv to the left of the treadway at .92 miles under pipeline. 2 pipe half full of debris. Water not draining and treadway has 2' of water on it. Needs to be dt into woods on right. (6) (see photo gd2)
